Emergency Asbestos Roof Sheet Repair in Armthorpe, Doncaster

Location:
Armthorpe, Doncaster

Roof Type / System:
Corrugated asbestos roof sheet — localised patch repair

Project Date / Year:
September 2026

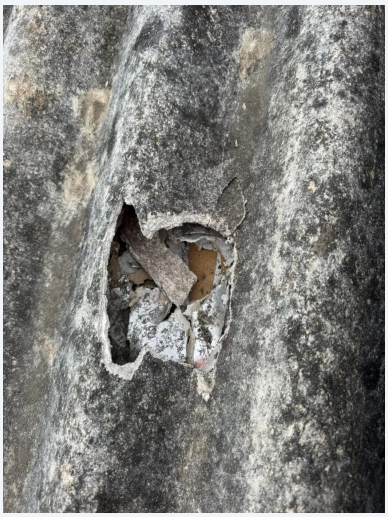
Project photograph

A steel rod had punctured and cracked a corrugated asbestos roof sheet. The affected part of the building had been closed off pending repair, so the client needed a prompt solution.

The reported damage was to a localised section of the corrugated roof sheet. The photos show the damaged opening and the completed repair. No wider roof area or additional repair requirements have been specified.

Carry out a localised patch repair to the damaged roof sheet, addressing the opening while keeping the scope focused on the affected area.

Elite Waterproofing attended three days after receiving the enquiry and completed a patch repair to the damaged section. The repair took less than one day.
