Corrugated Roof Repairs in Cirencester

Location:
Cirencester

Roof Type / System:
Corrugated roof repairs

Approximate Roof Area:
Approximately 150 m² across five areas

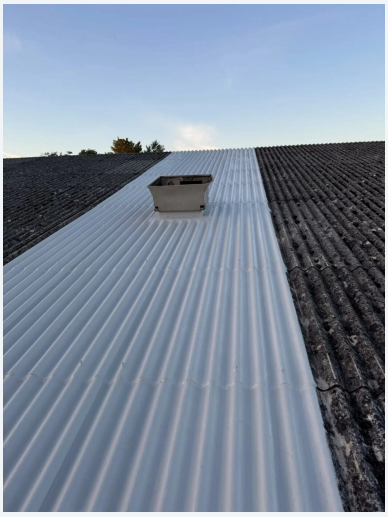
Project photograph

Cracks and splits at roof laps and joints were allowing water to pass beneath the sheets. Moss had accumulated along the corrugations and joints, adding to the conditions that let water track through the affected areas.

The client identified five sections requiring attention. The photos show moss and growth along the roof corrugations and joints, as well as close-up damage around a sheet lap. They also show several large repair areas beside existing roof sections and around a raised roof feature.

Carry out localised repairs across the five affected roof areas, addressing the cracks, splits and vulnerable laps and joints.

Repairs were completed across five sections, each approximately 3 metres wide and 8–10 metres long. Scaffolding was erected, dismantled and rebuilt as work moved around the site. The team maintained pedestrian access along the public right of way during the project.
